Article

# Corrosion and Tribology of Materials Used in a Novel Reverse Hip Replacement

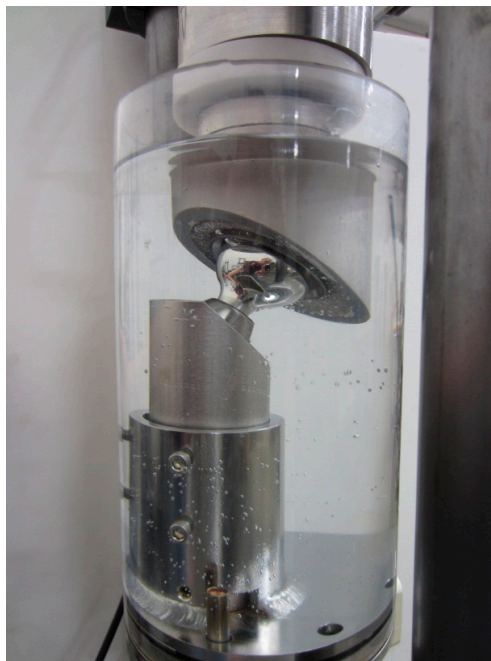
**Figure 2.** Test setup for corrosion evaluation via ISO 7206-6.

The corrosion potential of the reverse hip system was evaluated using an extended fatigue test. Specifically, the reverse hip system was dynamically tested via ISO 7206-6: 1992. Six hip stem assemblies were oriented at 10° adduction and 9° flexion such that the prescribed load was applied non-parallel to the plane of the neck as designated within the standard. The cementing level was the transection level of the femur as indicated by the superior edge of the porous coating. A custom load application fixture was manufactured to hold the acetabular component at the respective angles. The load applicator was mounted to a self-centering mobile bearing to allow for horizontal travel. The specimen was loaded into the test fixture, and the test chamber was filled with a 0.9% saline solution. The solution temperature was heated to and maintained at 37 °C, as shown in Figure 2. A sinusoidal load profile was applied in load control with a range between 534 and 5340 Newtons (120–1200 lbs. of force) at 10 Hz; the test was terminated at 50 million cycles.

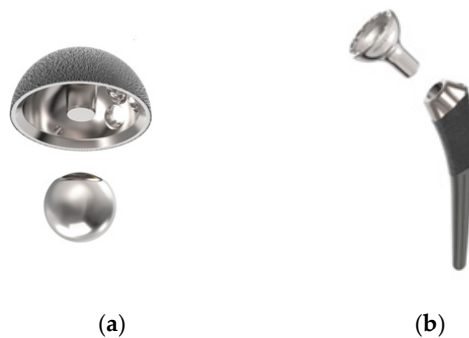
**Figure 3.** Tapers visually evaluated for corrosion: Acetabular Taper (a) and Femoral Taper (b).

The stems, femoral cups, acetabular cups, and acetabular balls were inspected after testing for evidence of failure and the tapers were evaluated for evidence of fretting corrosion. Both the acetabular taper between the acetabular cup and acetabular ball and the femoral taper between the femoral stem and the femoral cup, as shown in Figure 3, were evaluated.

Tapers were evaluated with both visual inspection for corrosion and the force needed to remove the ball from the Morse taper after the testing. The visual fretting corrosion was evaluated with the following scale presented at the ASTM Symposium on Metal on Metal Hip Symposium in May 2010:

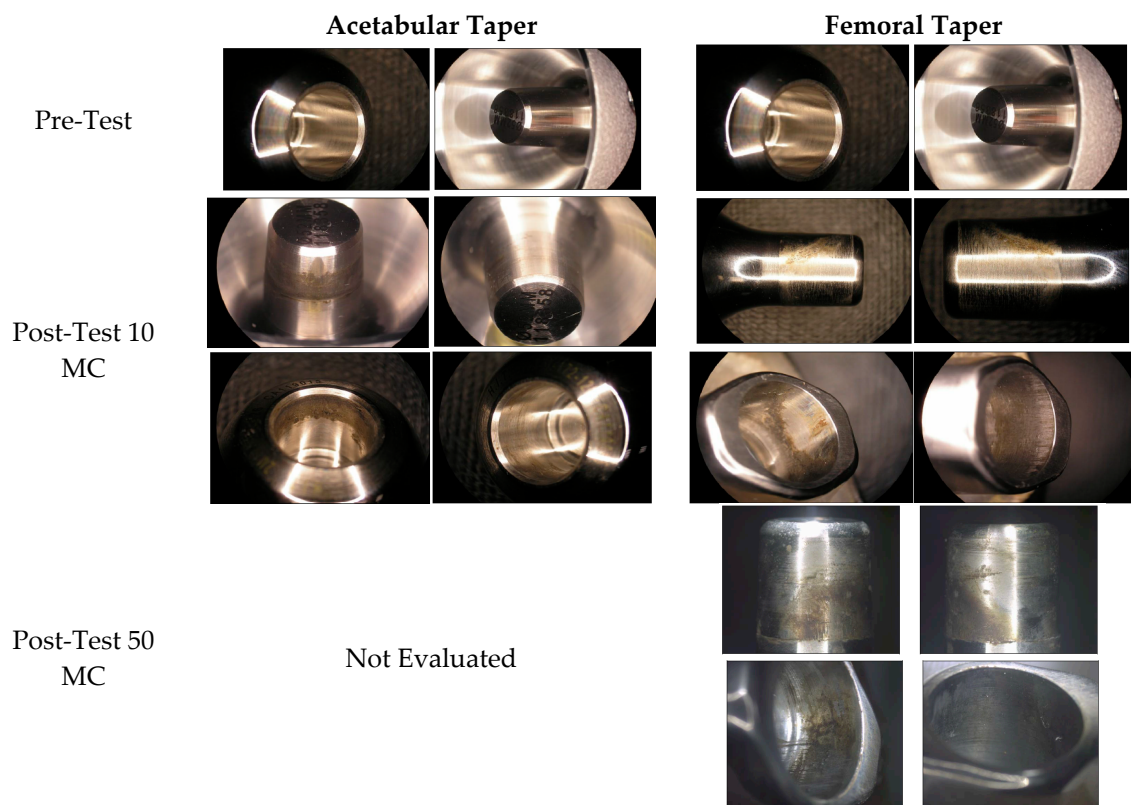
**Figure 4.** Representative examples of both acetabular and femoral tapers both pre- and post-testing for 10 and 50 million cycles.

The overall surface analysis of the acetabular tapers was performed after exposure to ISO 7206-6 testing in saline with a cyclic loading of 534–5340 Newtons applied at 10 Hz for a total of 50 million cycles. The surface of both the acetabular and femoral tapers were visually evaluated and did not show evidence of surface damage such as gouges, scratches, or structural damage. The grading of the levels of corrosion were scored as a 2 or 3 for the evaluation of the inferior, superior, anterior and posterior faces of all tapers after 10 million cycles indicating discoloration of the taper with minimally pitting or etch marks. Additional evaluation was performed on the femoral taper after a total of 50 million cycles resulting in scores of 2 to 4, indicating between discoloration to some level of pitting and etch marks via the visual analysis scale. Representative examples of the tapers both pre- and post-testing, as shown in Figure 4.
